WATER PENETRATION TESTING OF STUCCO ON CONCRETE MASONRY CONSTRUCTION

for
Florida Concrete & Products Association
and
NCMA Education and Research Foundation

Conducted by: Masonry Information Technologists
Jim Gulde, President

Project No. 05-466B
Date: May 2007

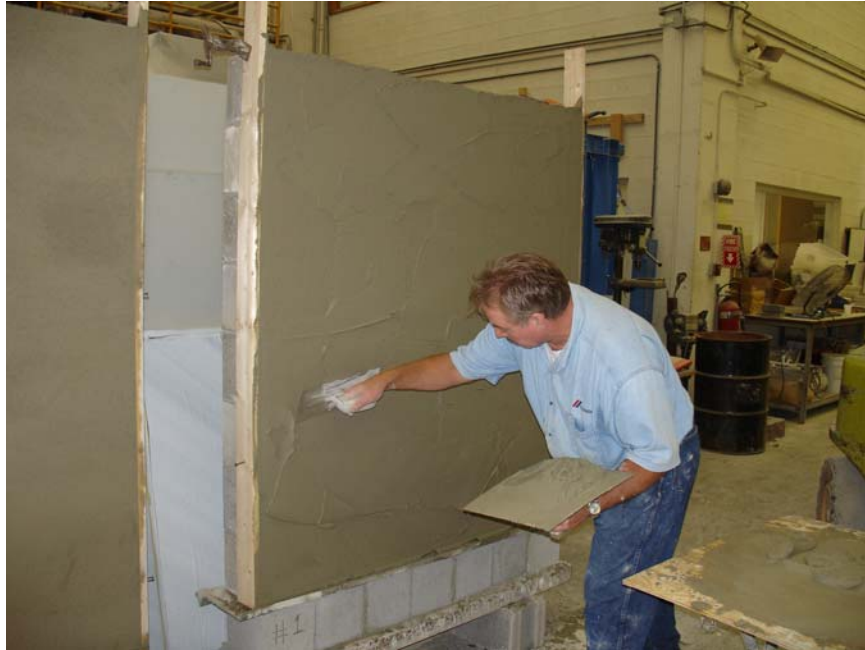
**Figure 6— The final step in the building of the walls
- the application of the stucco to the block.**

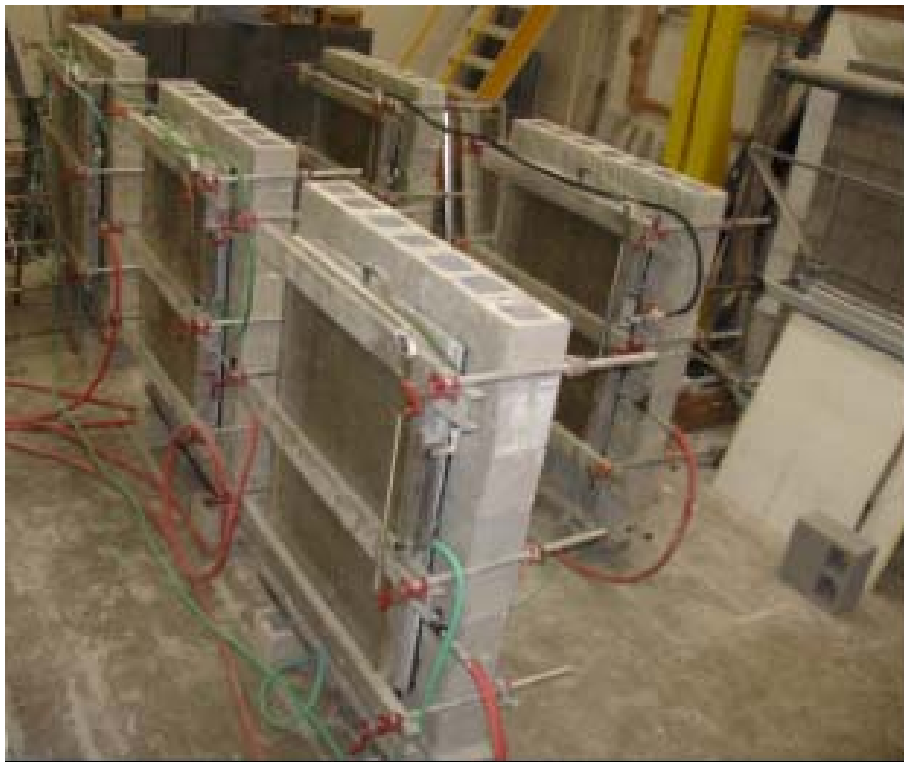
Figure 6—Phase I Test Walls
(Photo taken: December 19, 2005)

The walls in Phase I were tested at two pressures. Round one was tested at ASTM E514 prescribed water flow and pressure of 40.8 gallons per hour and 10 lbs per square foot (0.47 kPa) (2 in. (51 mm) of water) where wind velocity, V = approximately 62 mph (100 kph). Round two was tested at ASTM E514 prescribed water flow and 31 lbs per square foot (1.5 kPa) (6 in. (13 mm) of water) pressure. The higher pressure was calculated from the equation: $p = 0.00256(V)^2$ with $V = 110$ mph (177 kph) wind speed.

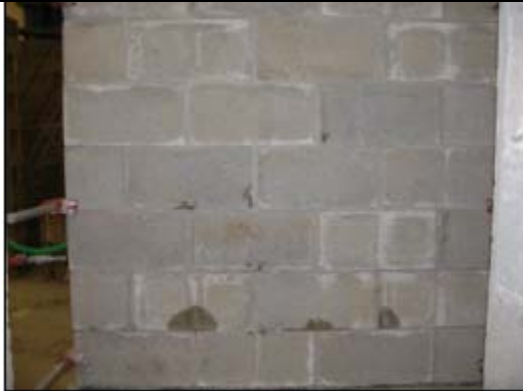
A photograph of a light-colored concrete masonry wall. At the bottom, there are several small, dark, irregular stains, indicating the beginning of water penetration.
1.0

In testing the blank (control) wall, the water and pressure commensurate with the 62 mph (100 kph) wind speed were maintained for 4 hours. Visible water was observed in the wall cores and the wall face within ½ hour. In addition, approximately 20 gallons of water penetrated the wall face under pressure and approximately 0.1 gallons migrated through the wall cross section. It is estimated that water flow rates of 5 gallons per hour and 0.03 gallons per hour would be attained for the wall face and wall cross section, respectively.

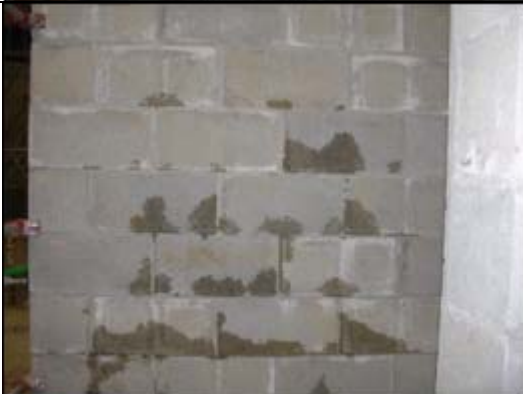
A photograph of the same wall. The dark stains at the bottom have significantly increased in size and number, spreading across more of the lower portion of the wall.
1.5

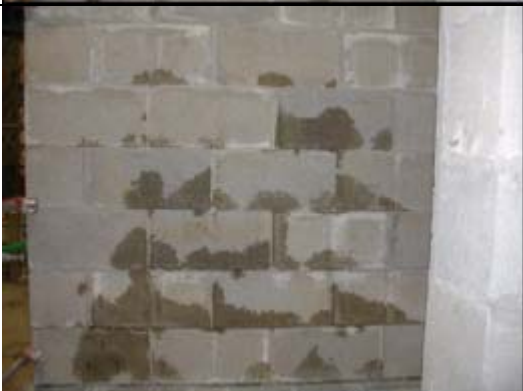
A photograph of the wall showing extensive water penetration. The dark stains are now large, dark, and widespread, covering a significant portion of the lower half of the wall.

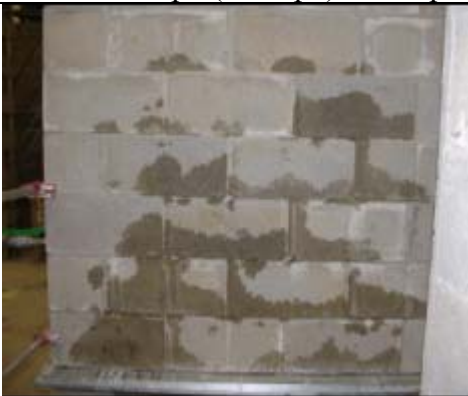
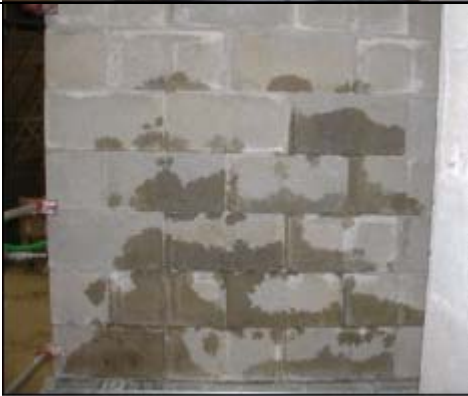
Observation Time (hr)	Control wall at 62 mph (100 kph) wind speed
2.0

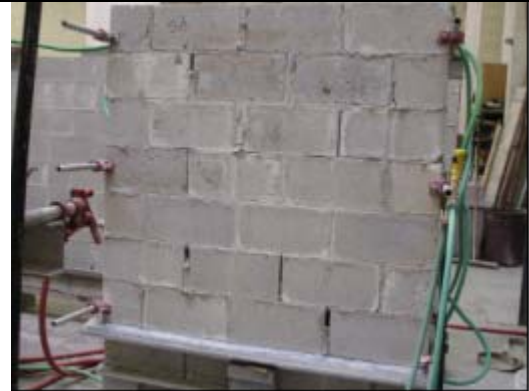
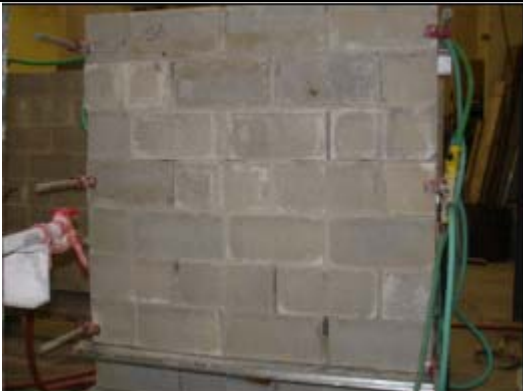
Table 4—Flawed Wall with 1/8 in. (3 mm) Skim Coat Performance, Phase I

Flawed wall with 1/8 in. (3 mm) skim coat after 4 hours at 62 mph (100 kph)	Flawed wall with 1/8 in. (3 mm) skim coat after 4 hours at 62 mph (100 kph) plus 24 hours at 110 mph (177 kph)

In the control wall (with no stucco) water was observed penetrating into the cores and dampness on the leeward wall face within 30 minutes at the 62 mph (100 kph) wind speed. The walls with $\frac{1}{8}$ in. (3 mm) and $\frac{1}{4}$ in. (6 mm) skim coats and $\frac{1}{2}$ in. (13 mm) stucco showed no evidence of water penetration during the four hours of 62 mph (100 kph) wind driven rain. Additionally, in the following 24 hours at 110 mph (177 kph) there was no trace of water entering the cores or dampness appearing on the leeward face of the wall. Each of the stucco material thicknesses had one wall with “flawed” mortar joints.

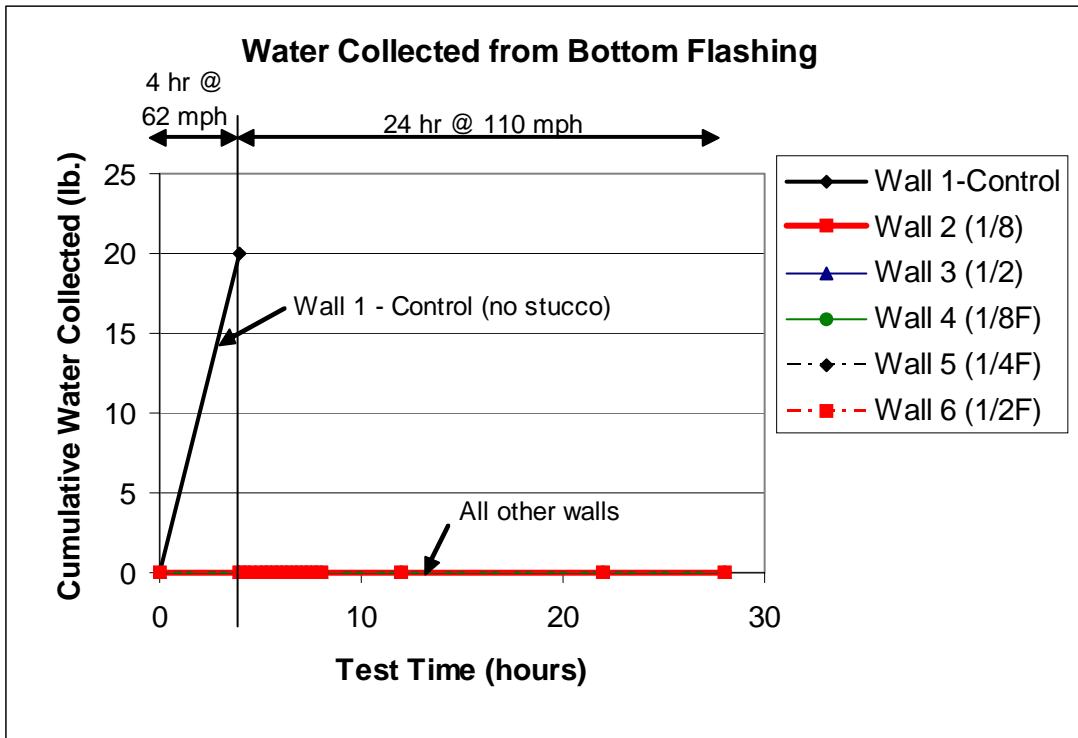
Figure 6—Test Results – Water Collected on Through-Wall Flashing, lbs.

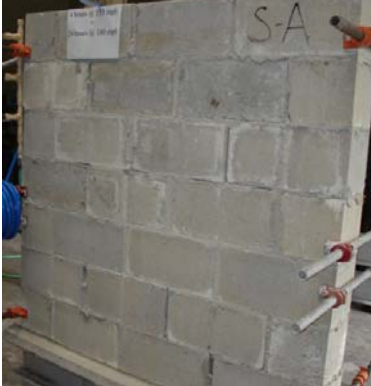
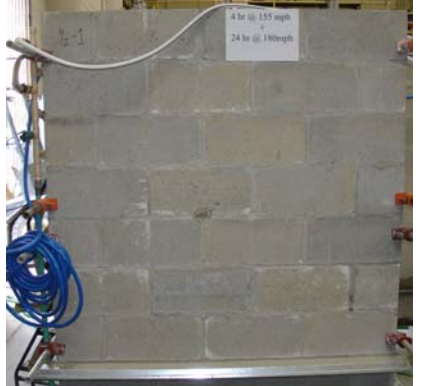
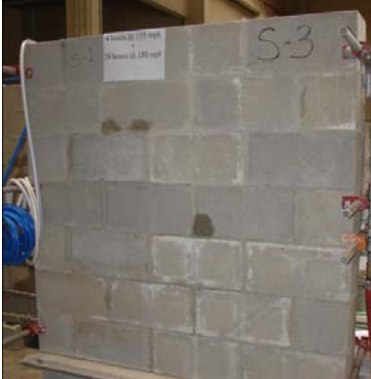
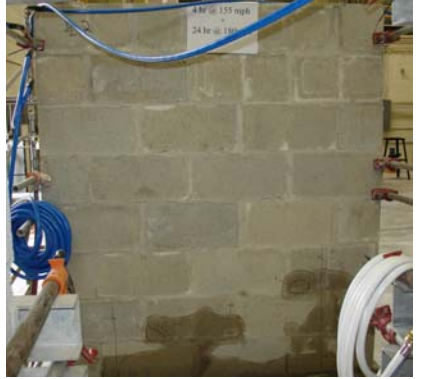
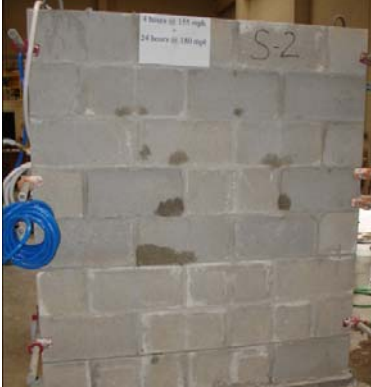
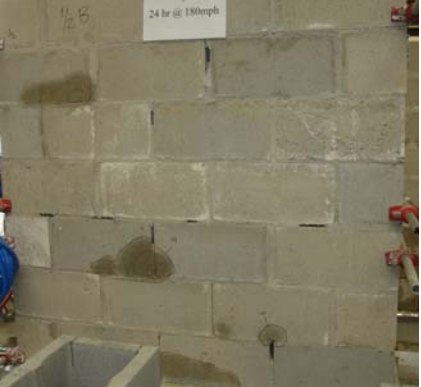
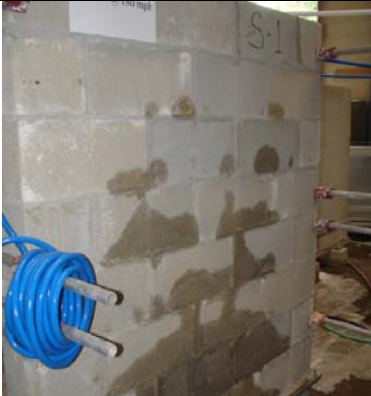
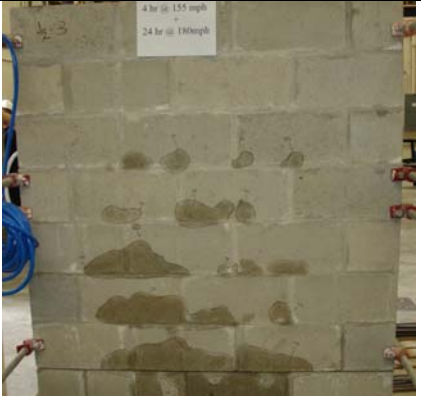
**Table 8—Walls After 4 Hours at 155 mph (249 kph)
then 24 hours at 180 mph (290 kph), Phase II,
Organized from Best to Worst Performing at Test Conclusion**

1/8 in. (3 mm) skim coat		1/2 in. (13 mm) stucco
Wall S-A Flawed Mortar Joints

Wall 1/2-1

Wall S-3

Wall 1/2-2

Wall S-2

Wall 1/2-B Flawed Mortar Joints

Wall S-1

Wall 1/2-3

After 4 hours of testing at 155 mph (249 kph) no moisture was observed in any of the cores or leakage on the leeward face in any of the test specimens. In view of this, there was little reason to continue the test to 24 hours since the object was to determine the difference in performance between walls. The pressure was then increased to that of a 180 mph (290 kph) wind. Almost immediately moisture appeared in the cores of the 1/8-in. (3 mm) coated walls. Therefore the test at 180 mph (290 kph) was continued for full 24 hours. Moisture in some form appeared on the back surface on three of the four walls. See photos in Table 5 and 6.

The 1/2 in. (13 mm) stucco walls were then tested at the same regimen as the 1/8-in. (3 mm) skim coat for comparison, i.e. 4 hrs at 155 mph (249 kph) followed by 24 hrs at 180 mph (290 kph). Again, there was no moisture observed in the first four hours at the lower wind pressure. Under the increased rate of 180 mph (290 kph), moisture was observed in the cores of these walls as well as moisture on the leeward face in some form on all four walls but in lesser overall amounts than for the 1/8-in. (3 mm) skim coat. See photos in Table 5 and 6.

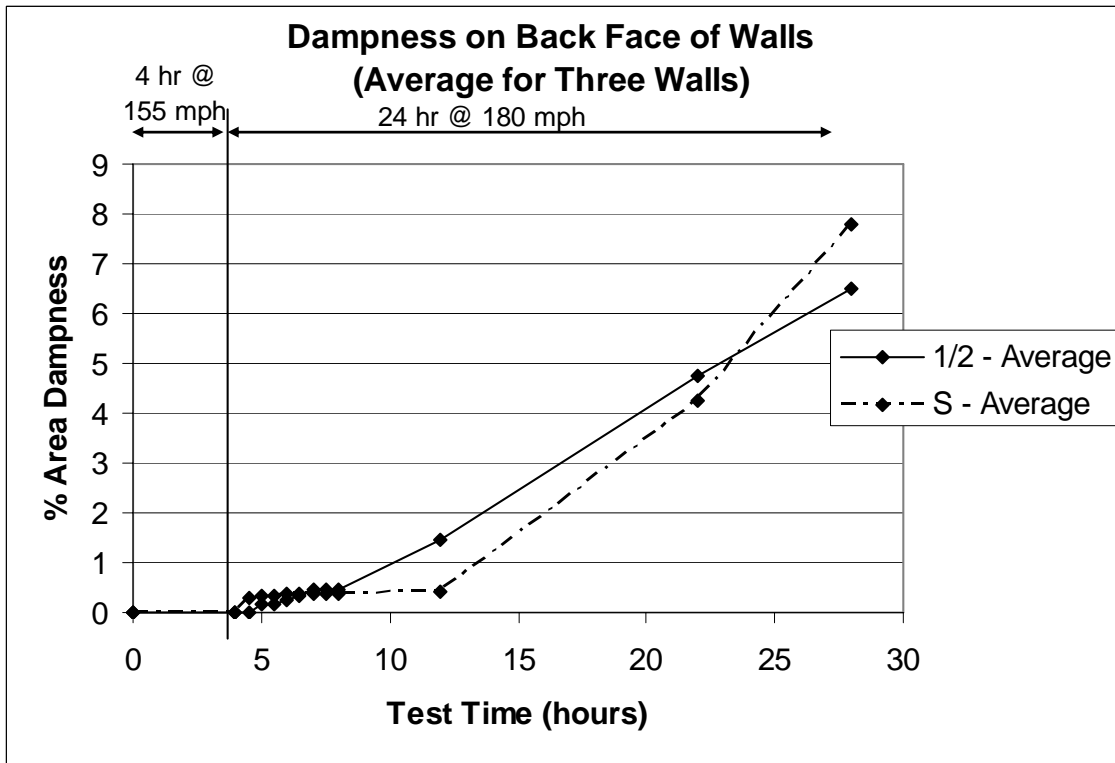
Figure 8—Test Results: Dampness 1/8 in. (3 mm) Skim Coat vs. 1/2 in. (13 mm) Stucco

At 180 mph (290 kph) for 24 hours, the walls with $\frac{1}{8}$ in. (3 mm) skim coat and the walls with $\frac{1}{2}$ in. (13 mm) stucco passed water into the cores and to the opposite face. Although data above and the charts show some differences, the results for the amount of water collected on the flashing for the $\frac{1}{8}$ in. (3 mm) skim coat and the $\frac{1}{2}$ in. (13 mm) stucco were dramatically different at the higher pressure as shown in Figure 9. Also the time at which water began collecting on the flashing was much earlier for the $\frac{1}{8}$ in. (3 mm) skim coat than for the $\frac{1}{2}$ in. (13 mm) stucco.

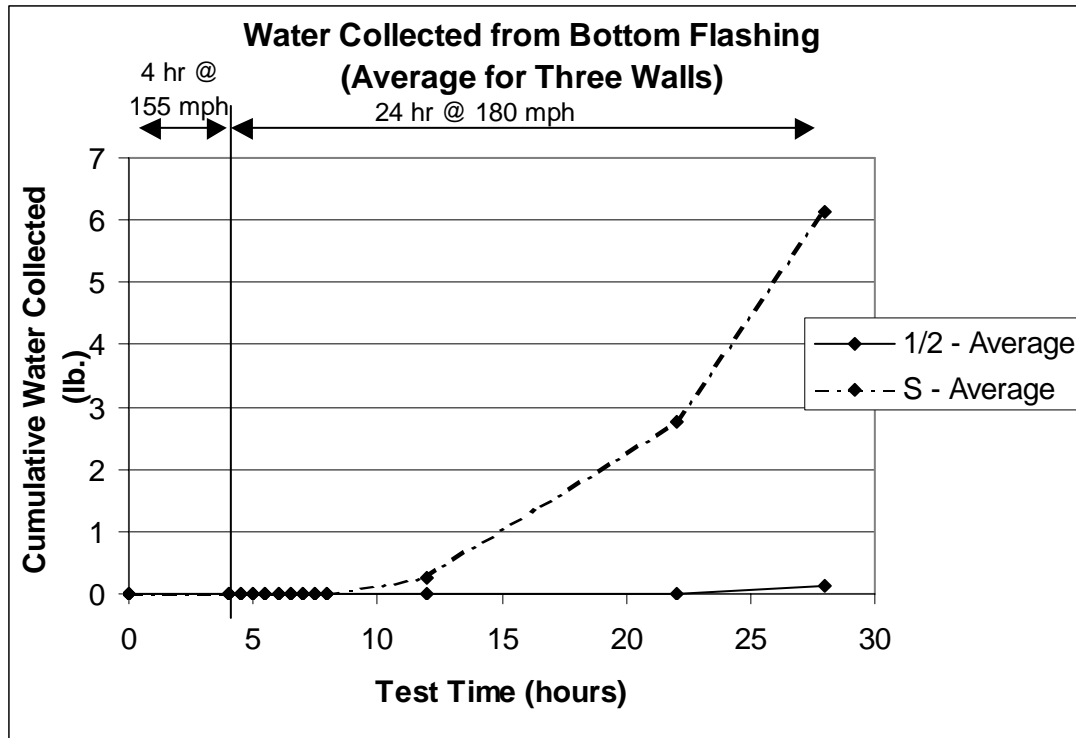
**Figure 9—Test Results – Water Collected on Flashing
 $\frac{1}{8}$ in. (3 mm) Skim Coat vs. $\frac{1}{2}$ in. (13 mm) Stucco.**
